**Installation Damage Testing
of Coated PET Geogrid:
40 kN/m
In Silty Sand**

SUBJECT: Installation Damage Testing of 40 kN/m Coated PET Geogrid In Silty Sand

**Installation Damage Testing
of Coated PET Geogrid:
80 kN/m
In Silty Sand**

SUBJECT: Installation Damage Testing of 80 kN/m Coated PET Geogrid In Silty Sand

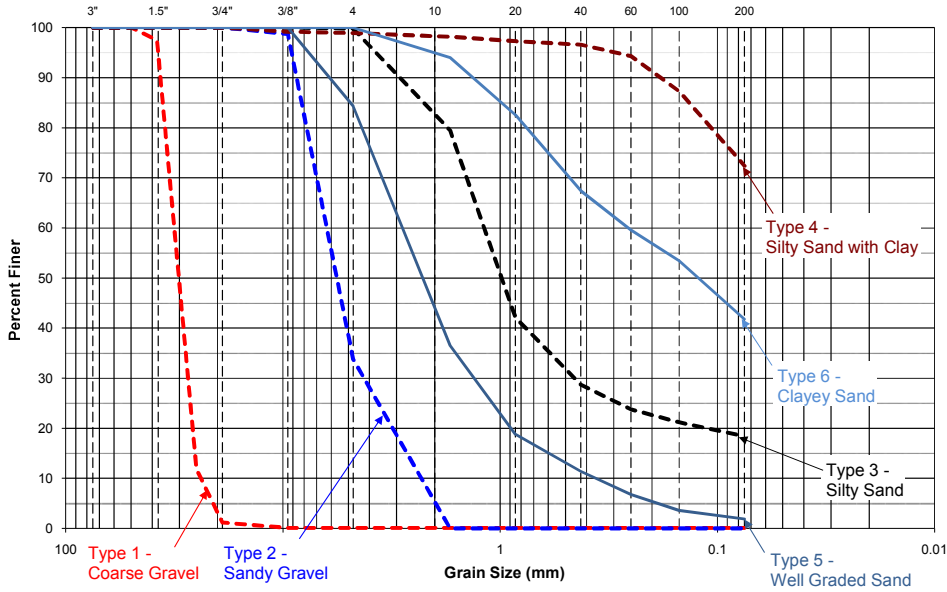
Grain Size Distribution - 2012 Standard Soils

INSTALLATION DAMAGE SOILS							
US Sieve No.	Sieve Size (mm)	Percent Passing					
		Type 1 (Coarse Gravel)	Type 2 (Sandy Gravel)	Type 3 (Silty Sand)	Type 4 (Silty Sand with Clay)	Type 5 (Well Graded Sand)	Type 6 (Clayey Sand)
3 - in.	75	100.0	100.0	100.0	100.0	100.0	100.0
2 - in.	50	100.0	100.0	100.0	100.0	100.0	100.0

Each geosynthetic was exposed to soils/aggregates chosen by the client from a range of available stockpiles having different gradations. The soil/aggregate used in this testing was silty sand (Type 3). Soil gradation curves may be found in the Appendix of this report.

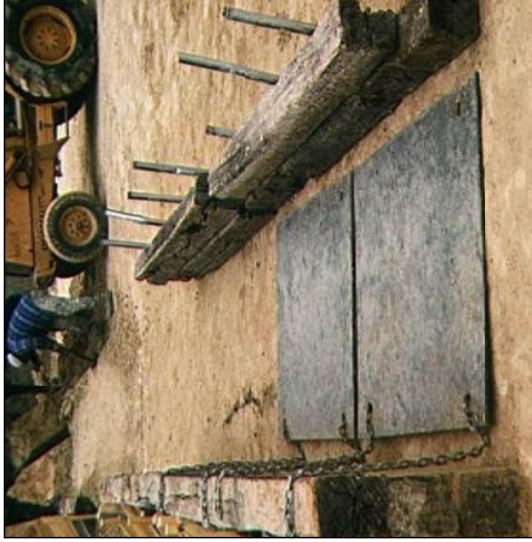
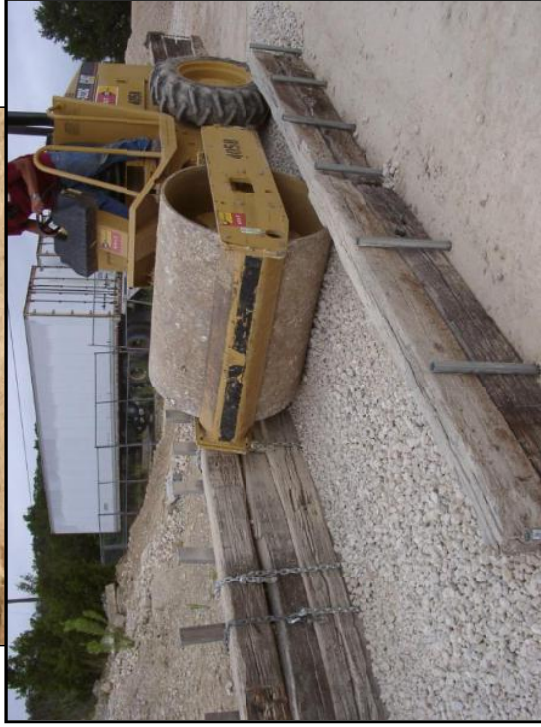
LIFTING PLATES POSITIONED BETWEEN TIES AND COVERED
WITH FIRST LIFT OF COMPACTED SOIL/AGGREGATE

Since compaction typically occurs parallel to the face of retaining walls and the contour lines of slopes, TRI placed the machine direction perpendicular to the running direction of the compaction equipment. To initiate the exposure procedure, four steel plates each measuring 42-inches x 52-inches (1.07 m x 1.32 m), equipped with lifting chains, were placed on a flat clean surface of hardened limestone rock. The longer side of the plates is parallel to the running direction of the compaction equipment. A layer of soil/aggregate was then placed over the adjacent plates to an approximate compacted thickness of 8 inches (0.20 m). Next, each of four coupons of the tested geosynthetic sample was placed on the compacted soil over an area corresponding to an underlying steel plate. To complete the installation, the second layer of soil was placed and compacted over the coupons to a thickness of 8 inches (0.20 m) using a vibratory

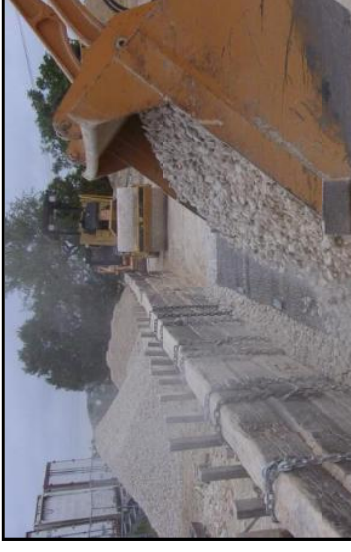
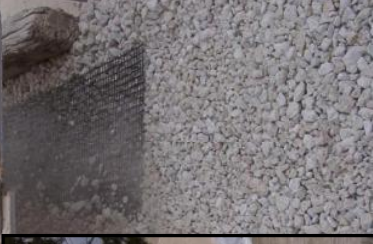
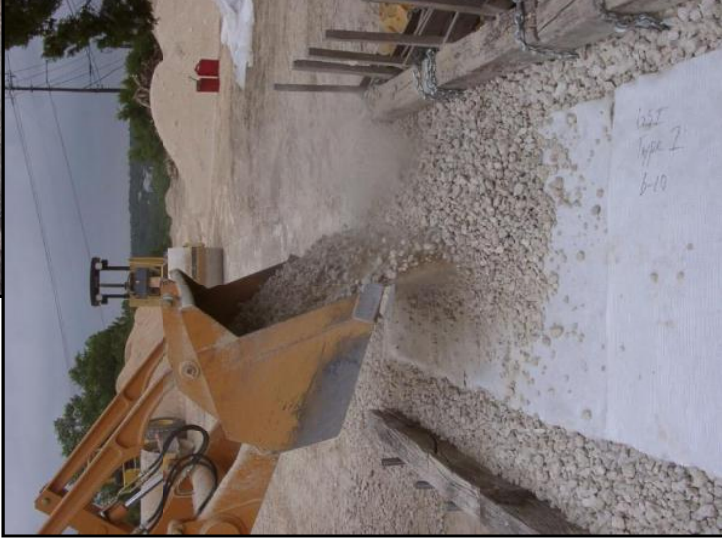
GEOSYNTHETIC POSITIONED OVER COMPACTED BASE AND
COVERED

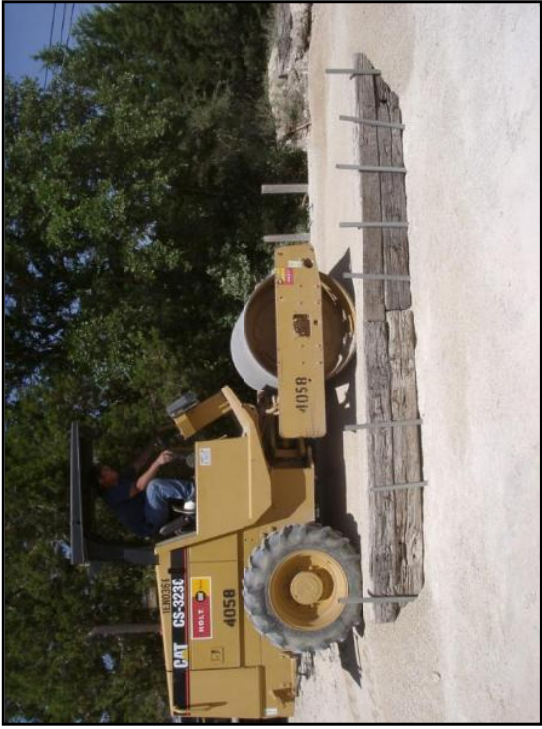
COVER SOIL/AGGREGATE IS UNIFORMLY SPREAD AND COMPACTED USING FIELD-SCALE EQUIPMENT AND PROCEDURES

Compaction was accomplished using a 4550 kg (10,000 lb) ride-on steel-wheeled roller with vibratory capability. All compaction and exhumation procedures, as well as laboratory soil classification and field thickness measurements, were performed under the supervision of TRI's Lead Geotechnical Technician. Density measurements were made by a qualified geotechnical technician.

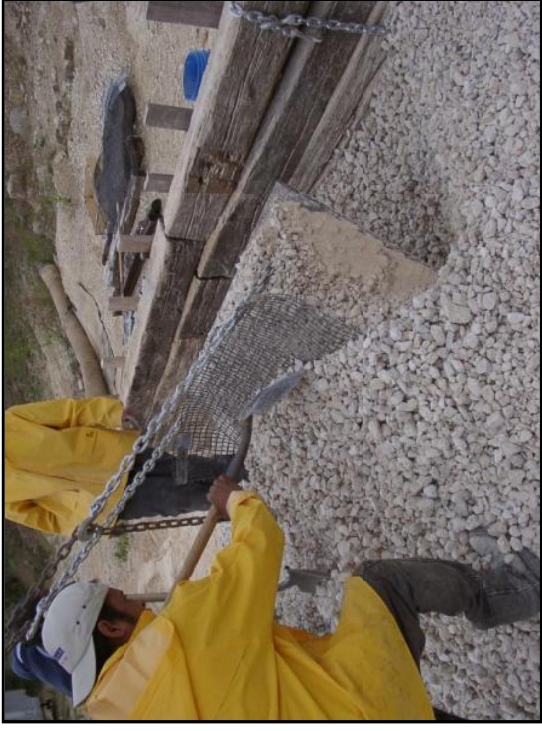
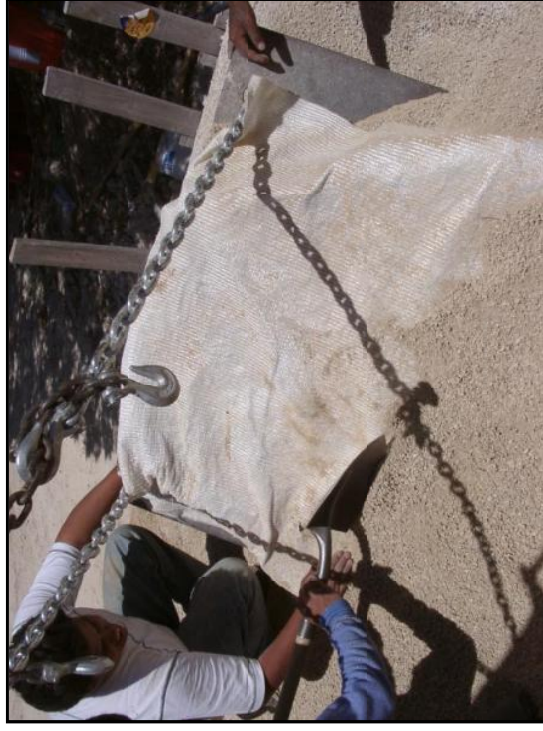
THE STEEL PLATES ARE TILTED TO FACILITATE EXHUMATION

To exhume the geosynthetic, railroad ties were removed and one end of each plate was raised with lifting chains. After raising the plate to about 45°, soil located near the bottom of the leaning plate was removed and, if necessary, the plate was struck with a sledgehammer to loosen the fill. The covering soil/aggregate was then carefully removed from the surface while "rolling" the geosynthetic away from the underlying soil/aggregate. This procedure assured a minimum of exhumation stress.

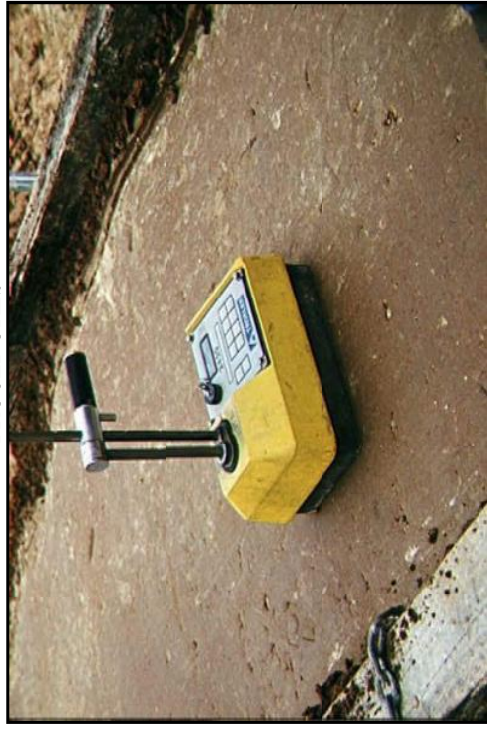
THE DENSITY OF COMPACTED SOIL IS MEASURED

- Proctor and sieve analyses were performed on each soil/aggregate, when possible. (Proctors could not be performed on Types 1 and 2)
- Lift thickness measurements were made after soil/aggregate compaction.
- When possible, moisture and density measurements were made on each lift using a nuclear density gage to confirm that densities >90% of modified Proctor (per ASTM D 1557) were being achieved.

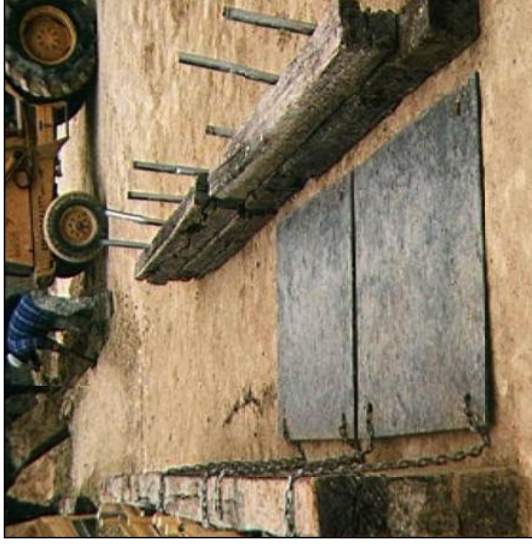
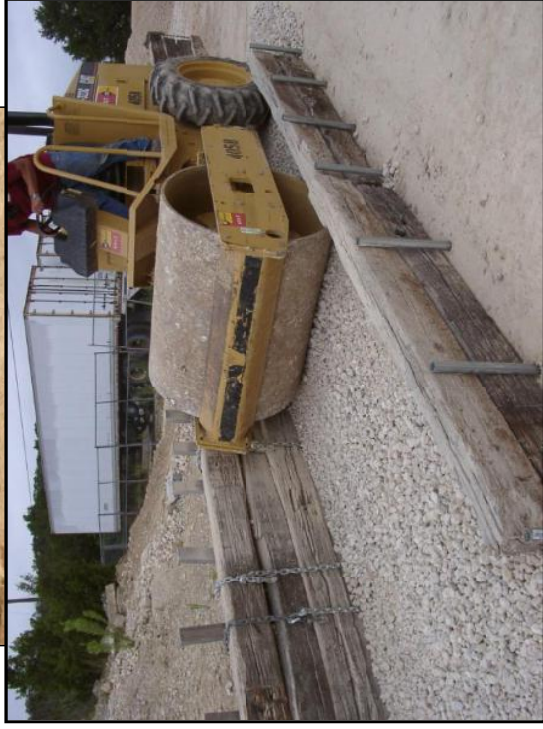
LIFTING PLATES POSITIONED BETWEEN TIES AND COVERED
WITH FIRST LIFT OF COMPACTED SOIL/AGGREGATE

Since compaction typically occurs parallel to the face of retaining walls and the contour lines of slopes, TRI placed the machine direction perpendicular to the running direction of the compaction equipment. To initiate the exposure procedure, four steel plates each measuring 42-inches x 52-inches (1.07 m x 1.32 m), equipped with lifting chains, were placed on a flat clean surface of hardened limestone rock. The longer side of the plates is parallel to the running direction of the compaction equipment. A layer of soil/aggregate was then placed over the adjacent plates to an approximate compacted thickness of 8 inches (0.20 m). Next, each of four coupons of the tested geosynthetic sample was placed on the compacted soil over an area corresponding to an underlying steel plate. To complete the installation, the second layer of soil was placed and compacted over the coupons to a thickness of 8 inches (0.20 m) using a vibratory

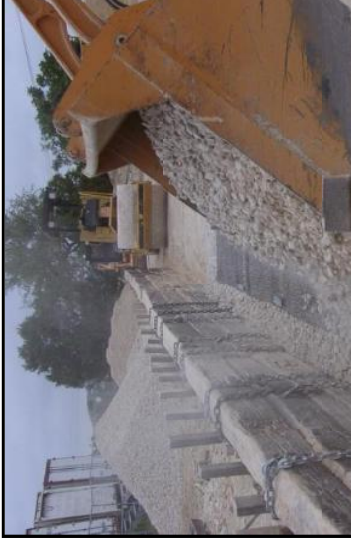
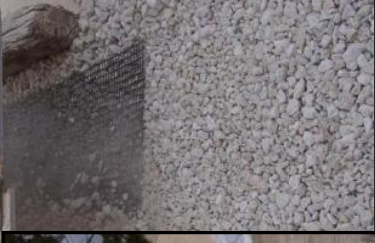
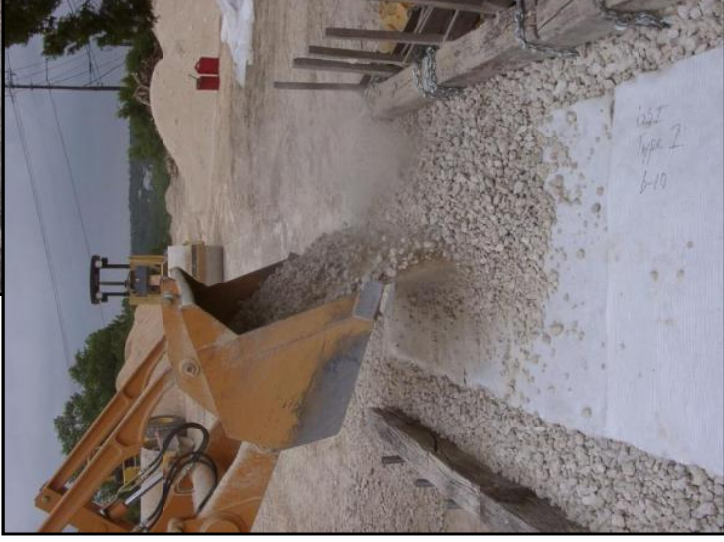
GEOSYNTHETIC POSITIONED OVER COMPACTED BASE AND
COVERED

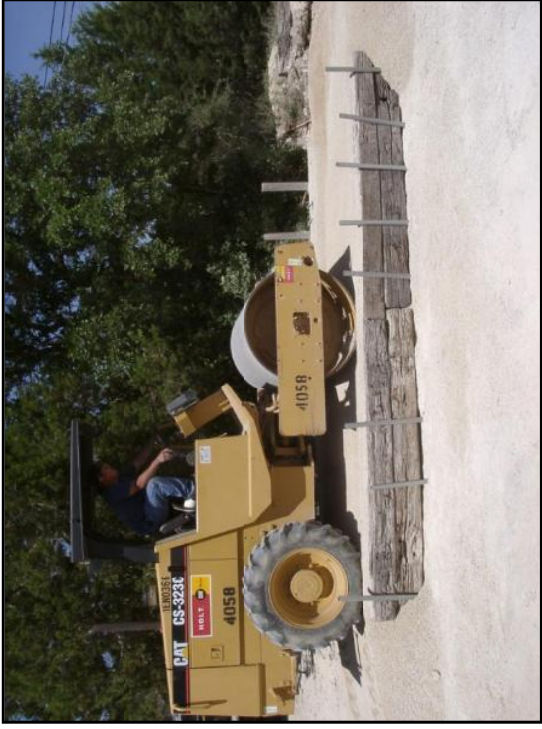
COVER SOIL/AGGREGATE IS UNIFORMLY SPREAD AND COMPACTED USING FIELD-SCALE EQUIPMENT AND PROCEDURES

Compaction was accomplished using a 4550 kg (10,000 lb) ride-on steel-wheeled roller with vibratory capability. All compaction and exhumation procedures, as well as laboratory soil classification and field thickness measurements, were performed under the supervision of TRI's Lead Geotechnical Technician. Density measurements were made by a qualified geotechnical technician.

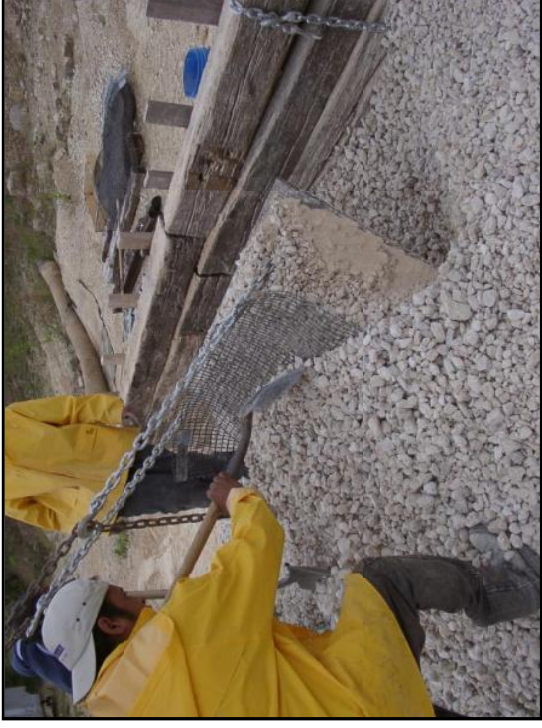
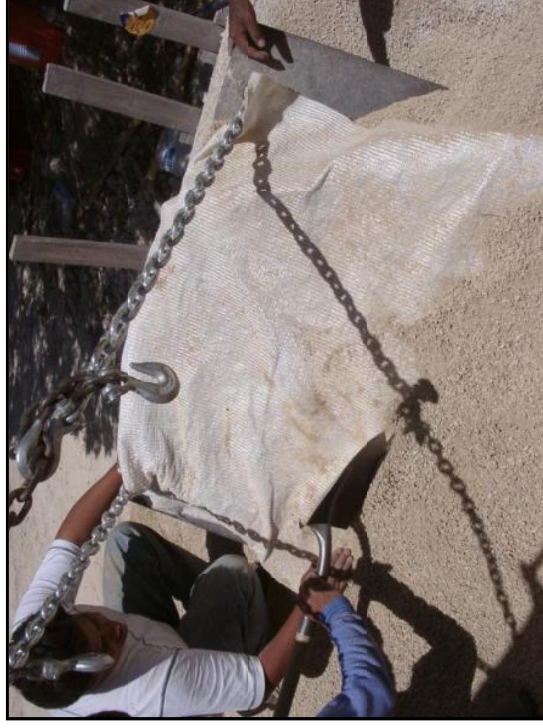
THE STEEL PLATES ARE TILTED TO FACILITATE EXHUMATION

To exhume the geosynthetic, railroad ties were removed and one end of each plate was raised with lifting chains. After raising the plate to about 45°, soil located near the bottom of the leaning plate was removed and, if necessary, the plate was struck with a sledgehammer to loosen the fill. The covering soil/aggregate was then carefully removed from the surface while "rolling" the geosynthetic away from the underlying soil/aggregate. This procedure assured a minimum of exhumation stress.
