# SGI TESTING SERVICES

Subject: Laboratory Test Results Transmittal  
Connection Strength Testing  
CTMGGU 40, CTMGGU 60, and CTMGGU 80 Geogrids between  
9 inch Deep Omega Blocks

**CTM TECHNICAL TEXTILES LTD.  
CONNECTION STRENGTH TESTING (ASTM D 6638)**

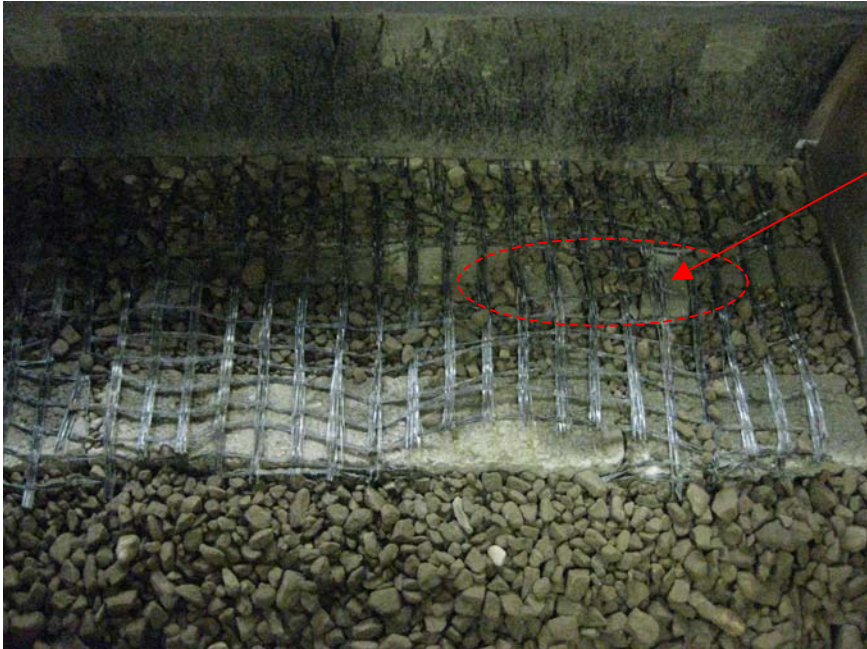
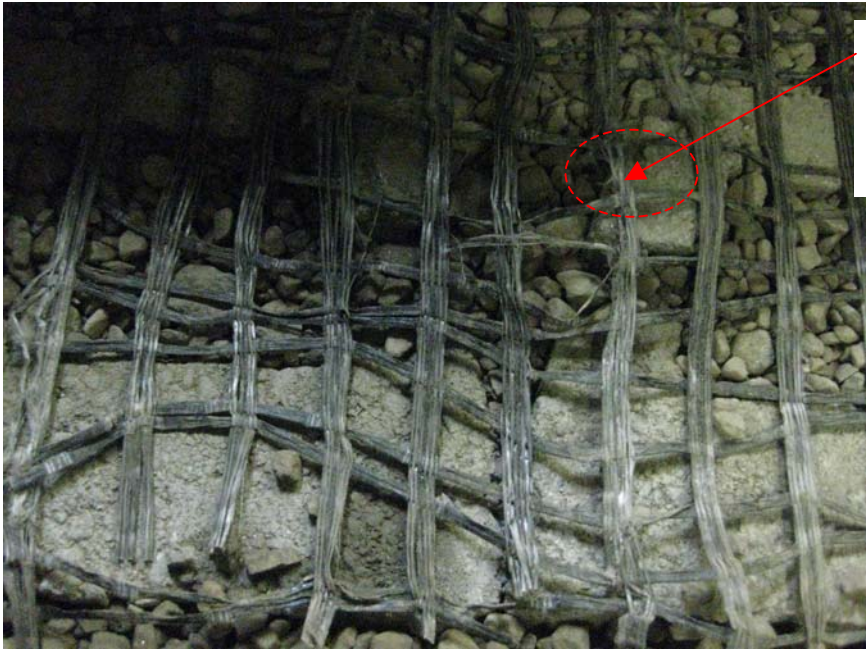
Shear keys

Rupture of a geogrid rib against shear key

Figure A-3. Typical failure mode: sliding of XD ribs (junction failure), abrasion damage to, and rupture of geogrid ribs.

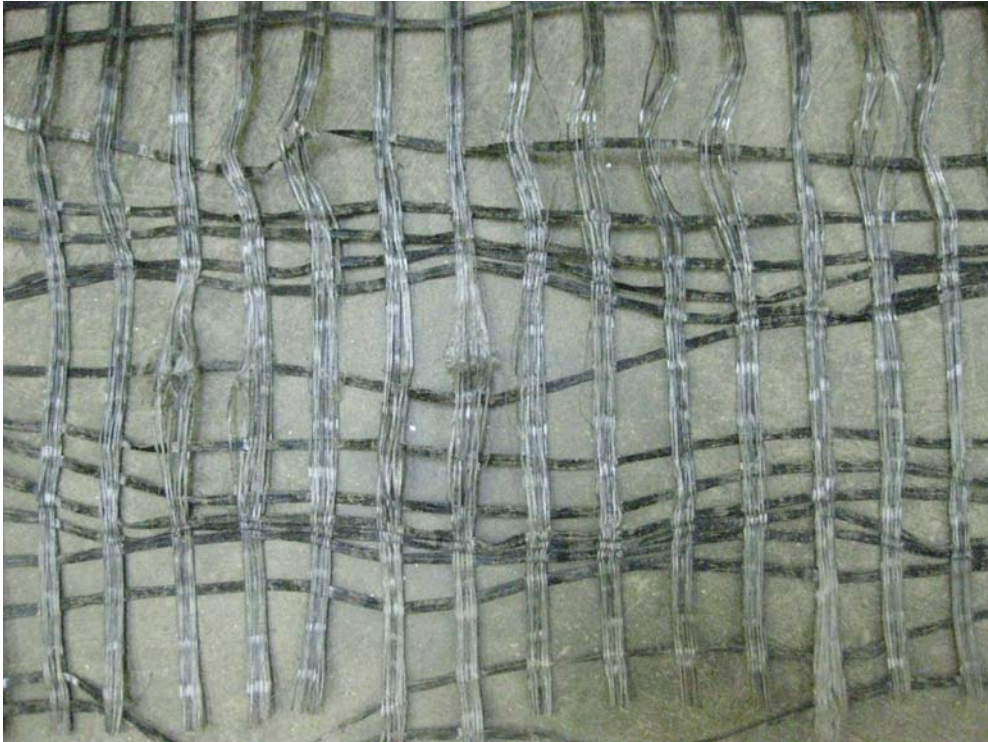
Figure A-4. Junction failure (sliding of a XD rib along MD ribs) of CTMGGU 60 geogrid at the completion of test #2C at 1125 lbs/ft normal load.

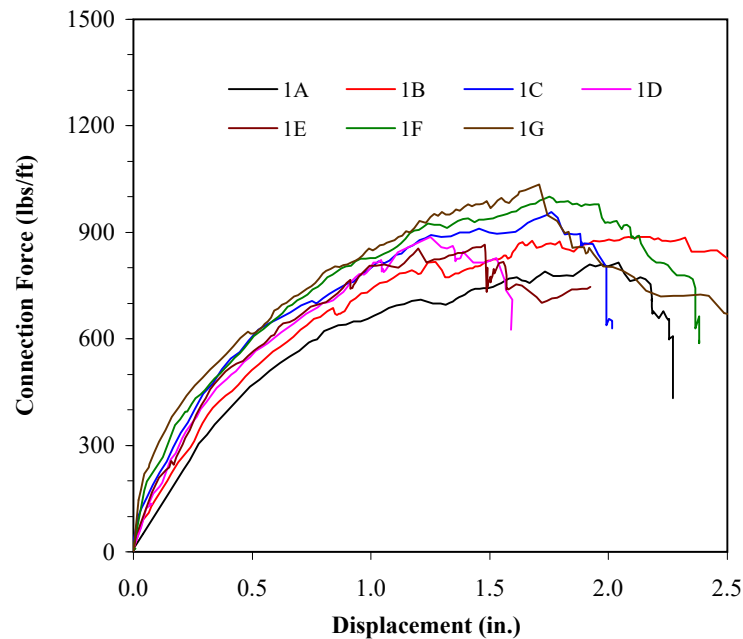
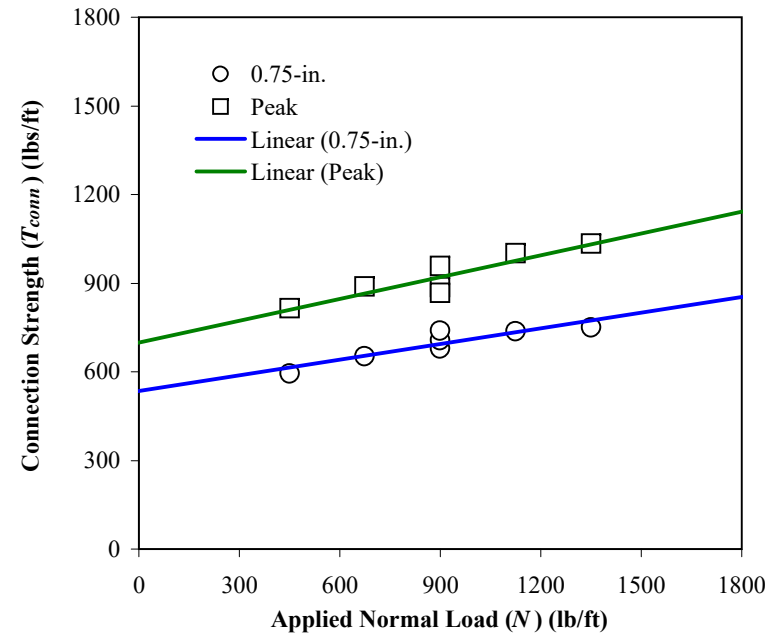
DATE REPORTED: 9/10/2016  
 FIGURE NO. C-1  
 PROJECT NO. SGI13020  
 DOCUMENT NO.  
 FILE NO.

TEST SERIES NO. 1: CTMGGU 40 geogrid in machine direction between two courses of 9" deep Omega blocks with compacted AASHTO #57 stone in block cores and spaces between blocks

Test No.	Geogrid Specimen Width <i>W</i> (in.)	Test Normal Stress $\sigma_n$ (psi)	Equivalent Normal Load <i>N</i> (lb/ft)	Approximate No. of Blocks <i>n</i>	Approximate Wall Height <i>h</i> (ft)	0.75-in. Strength $T_{0.75-in}$ (lb/ft)	Peak Strength $T_{peak}$ (lb/ft)	Connection Strength Equations (Strength assumed to be linearly related to <i>N</i> )
1A	32.0	4.2	450	8	5.0	593	814	$T_{0.75-in.} = 535 + (N) \tan ( 10^\circ )$ $T_{peak} = 700 + (N) \tan ( 14^\circ )$
1B	32.0	6.3	675	11	7.5	651	888	
1C	32.0	8.3	900	15	10.0	679	957	
1D	32.0	8.3	900	15	10.0	707	886	
1E	32.0	8.3	900	15	10.0	739	866	
1F	32.0	10.4	1125	19	12.5	736	1001	
1G	32.0	12.5	1350	23	15.0	749	1034

**NOTES:**  
 Nominal Dimensions of Block: 18" wide x 9" deep x 8" thick  
 Weight of Full-Size Block: 70 lbs  
 Average Unit Weight of Facing: 120 pcf.  
 Failure Mode: Rupture of MD geogrid ribs against shear keys in each test.

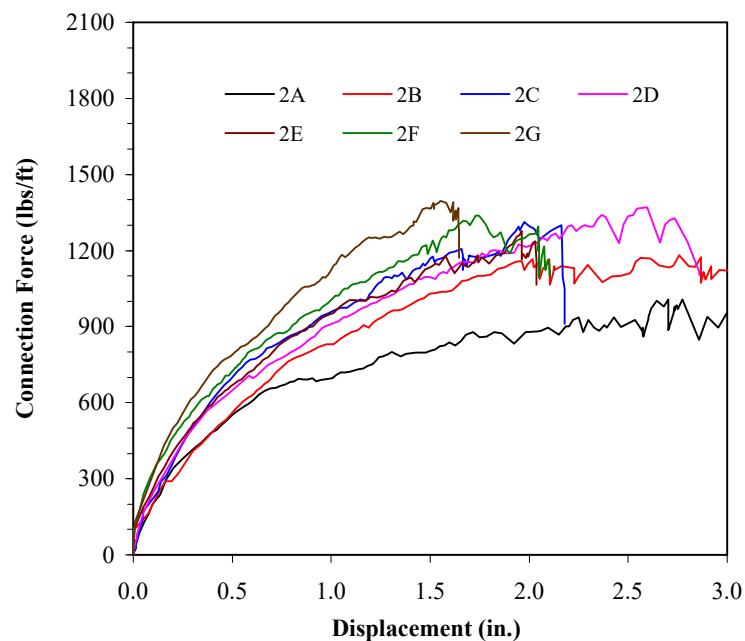
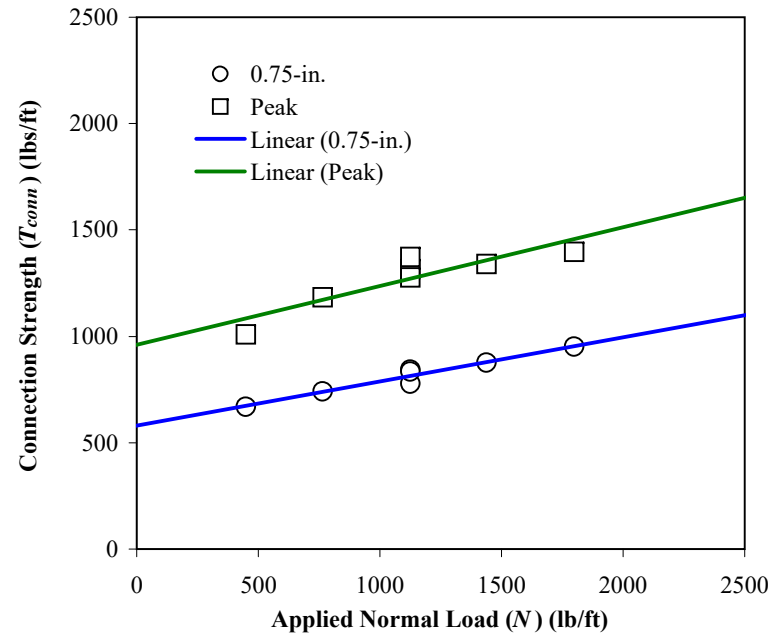
DATE REPORTED: 9/10/2016  
 FIGURE NO. C-2  
 PROJECT NO. SGI13020  
 DOCUMENT NO.  
 FILE NO.

TEST SERIES NO. 2: CTMGGU 60 geogrid in machine direction between two courses of 9" deep Omega blocks with compacted AASHTO #57 stone in block cores and spaces between blocks

Test No.	Geogrid Specimen Width $W$ (in.)	Test Normal Stress $\sigma_n$ (psi)	Equivalent Normal Load $N$ (lb/ft)	Approximate No. of Blocks $n$	Approximate Wall Height $h$ (ft)	0.75-in. Strength $T_{0.75-in}$ (lb/ft)	Peak Strength $T_{peak}$ (lb/ft)	Connection Strength Equations (Strength assumed to be linearly related to $N$ )
2A	32.0	4.2	450	8	5.0	668	1007	$T_{0.75-in.} = 580 + (N) \tan ( 12^\circ )$ $T_{peak} = 960 + (N) \tan ( 15^\circ )$
2B	32.0	7.1	765	13	8.5	740	1181	
2C	32.0	10.4	1125	19	12.5	843	1313	
2D	32.0	10.4	1125	19	12.5	776	1371	
2E	32.0	10.4	1125	19	12.5	834	1276	
2F	32.0	13.3	1440	24	16.0	875	1337	
2G	32.0	16.7	1800	30	20.0	950	1395

**NOTES:**  
 Nominal Dimensions of Block: 18" wide x 9" deep xx 8" thick  
 Weight of Full-Size Block: . 70 lbs  
 Average Unit Weight of Facing: 120 pcf.  
 Failure Mode: Rupture of MD geogrid ribs against shear keys in each test.

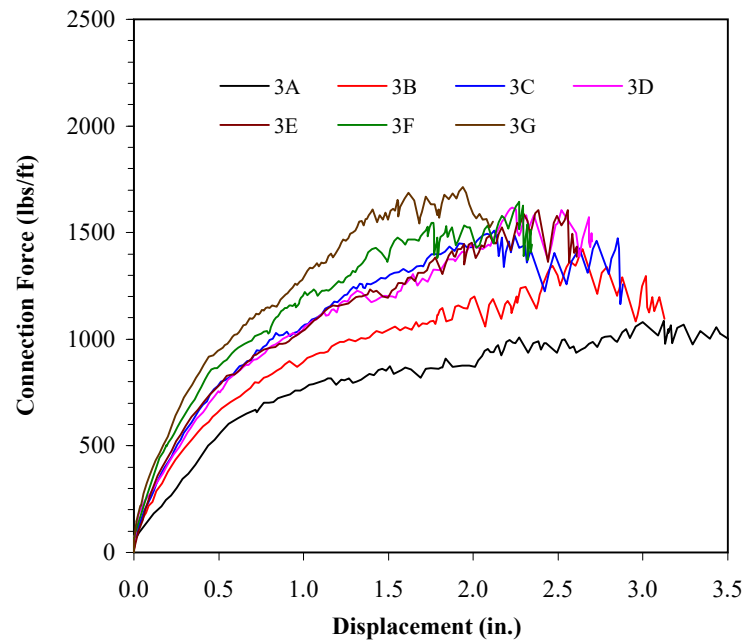
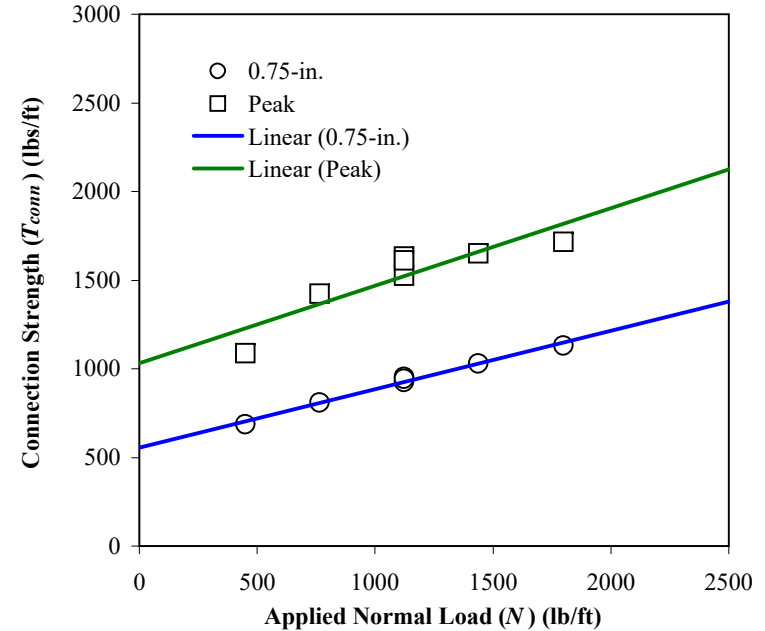
DATE REPORTED: 9/10/2016  
 FIGURE NO. C-3  
 PROJECT NO. SGI13020  
 DOCUMENT NO.  
 FILE NO.

TEST SERIES NO.3: CTMGGU 80 geogrid in machine direction between two courses of 9" deep Omega blocks with compacted AASHTO #57 stone in block cores and spaces between blocks

Test No.	Geogrid Specimen Width $W$ (in.)	Test Normal Stress $\sigma_n$ (psi)	Equivalent Normal Load $N$ (lb/ft)	Approximate No. of Blocks $n$	Approximate Wall Height $h$ (ft)	0.75-in. Strength $T_{0.75-in}$ (lb/ft)	Peak Strength $T_{peak}$ (lb/ft)	Connection Strength Equations (Strength assumed to be linearly related to $N$ )
3A	32.0	4.2	450	8	5.0	685	1087	$T_{0.75-in.} = 555 + (N) \tan ( 18^\circ )$ $T_{peak} = 1030 + (N) \tan ( 24^\circ )$
3B	32.0	7.1	765	13	8.5	807	1422	
3C	32.0	10.4	1125	19	12.5	953	1525	
3D	32.0	10.4	1125	19	12.5	923	1632	
3E	32.0	10.4	1125	19	12.5	943	1611	
3F	32.0	13.3	1440	24	16.0	1028	1649	
3G	32.0	16.7	1800	30	20.0	1130	1713

**NOTES:**  
 Nominal Dimensions of Block: 18" wide x 9" deep xx 8" thick  
 Weight of Full-Size Block: . 70 lbs  
 Average Unit Weight of Facing: 120 pcf.  
 Failure Mode: Rupture of MD geogrid ribs against shear keys in each test.
