# SGI TESTING SERVICES

Subject: Laboratory Test Results Transmittal  
Connection Strength Testing  
CTMGGU 40, CTMGGU 60, and CTMGGU 80 Geogrids between  
12 inch Deep Omega Blocks

**CTM TECHNICAL TEXTILES LTD.  
CONNECTION STRENGTH TESTING (ASTM D 6638)**

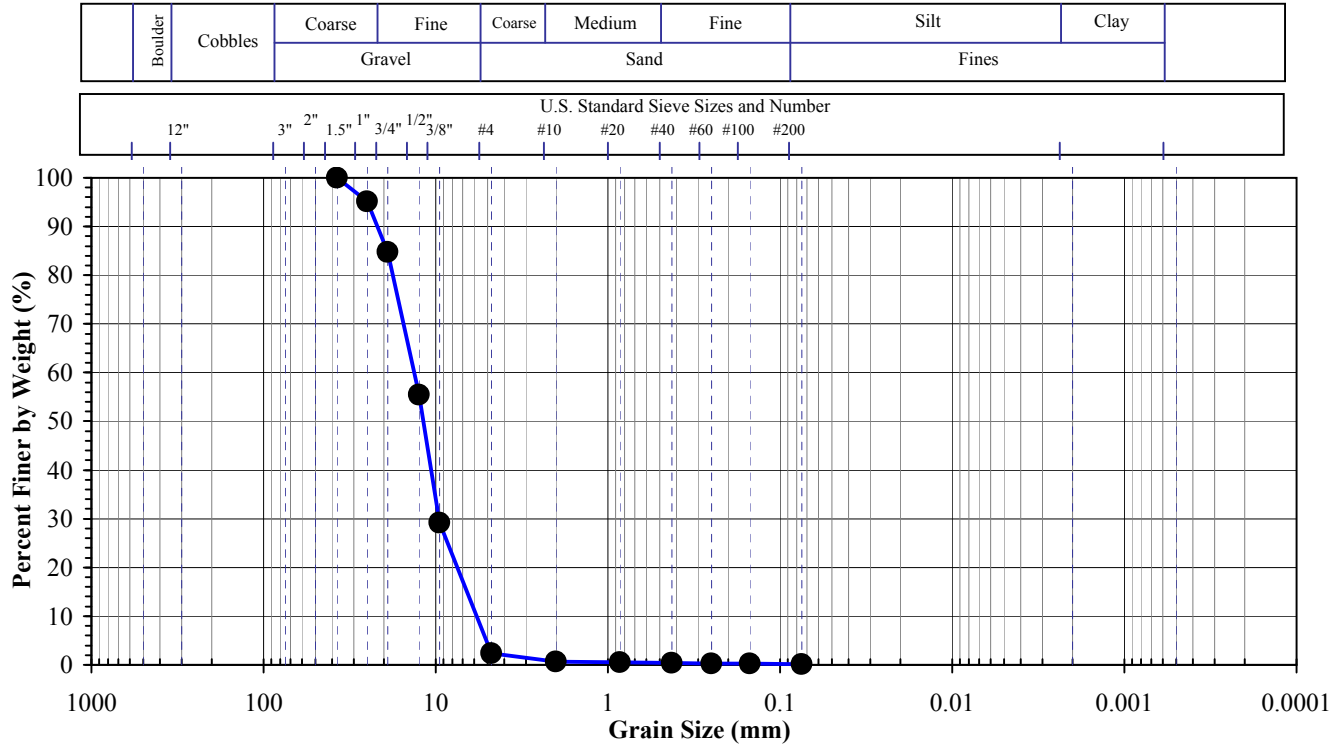
## SOIL INDEX PROPERTIES

Sieve No.	Size (mm)	% Finer
3"	75	
2"	50	
1.5"	37.5	100.0
1"	25	95.2
3/4"	19	84.8
1/2"	12.5	55.4
3/8"	9.5	29.2
#4	4.75	2.3
#10	2.00	0.7
#20	0.850	0.5
#40	0.425	0.3
#60	0.250	0.3
#100	0.150	0.3
#200	0.075	0.1

Gravel (%):	97.7
Sand (%):	2.2
Fines (%):	0.1
Silt (%):	0.1
Clay (%):

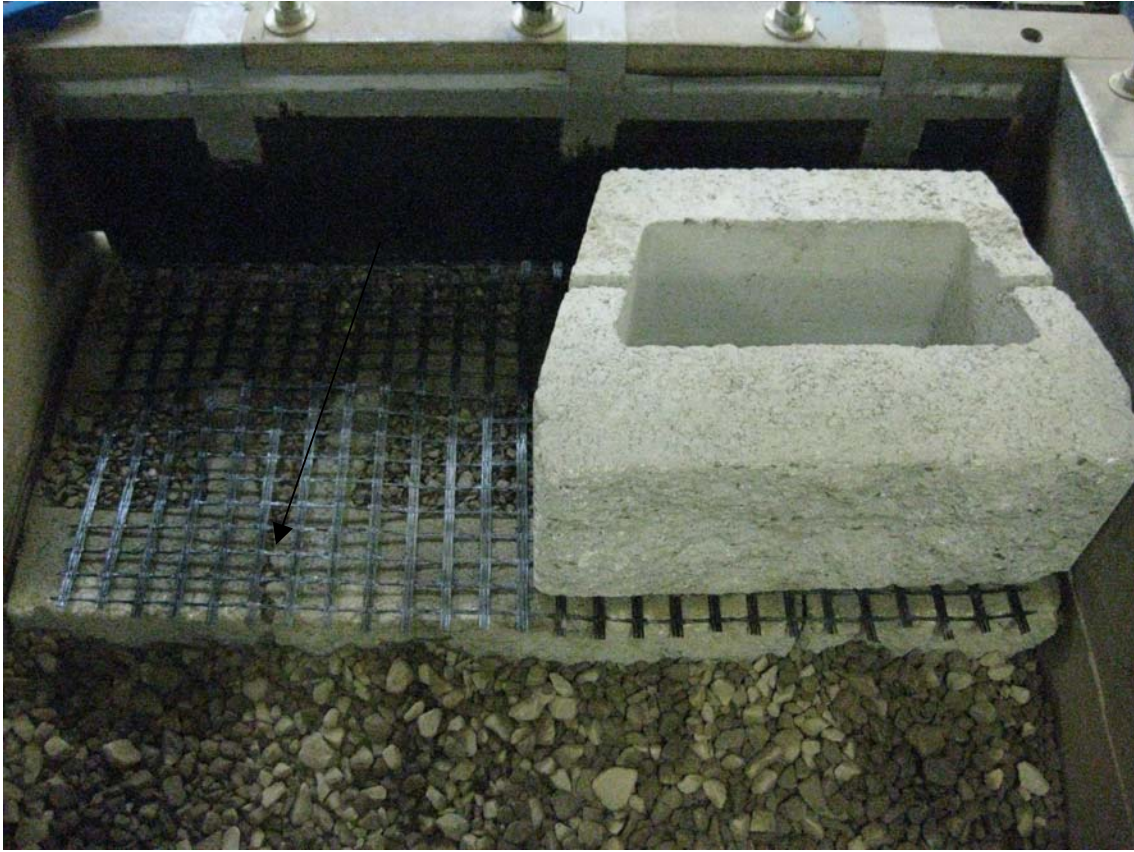
Figure A-2. Connection test setup.

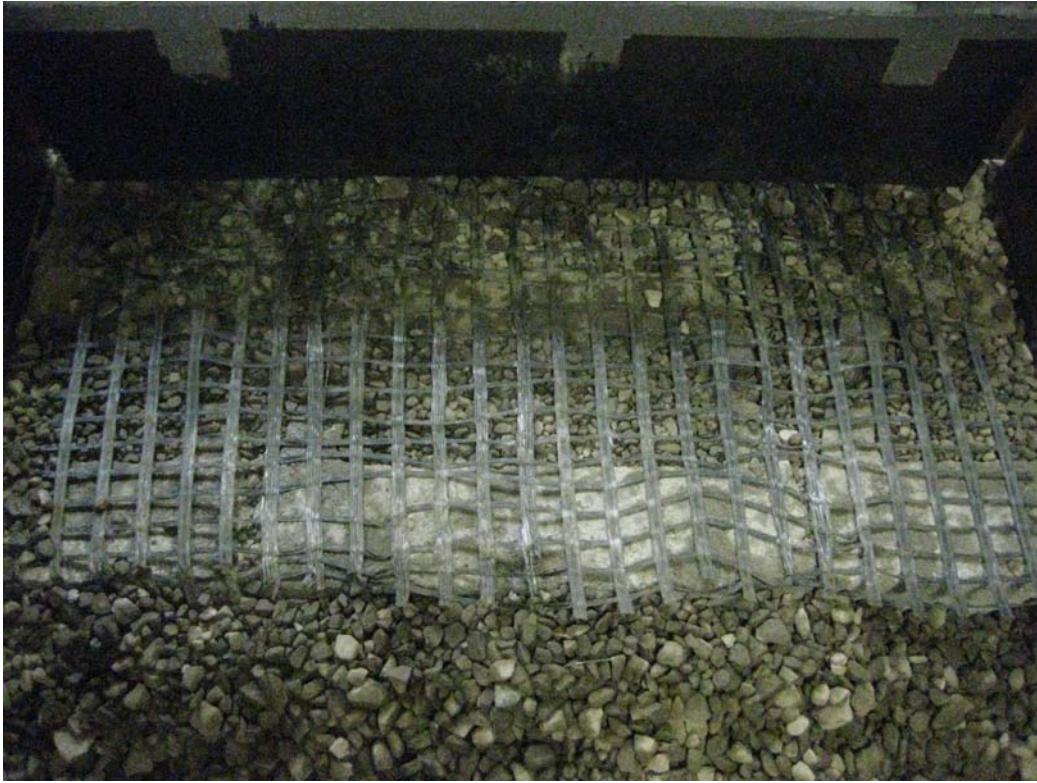
Figure A-3. Typical failure mode: sliding of XD ribs (junction failure), abrasion damage to, and rupture of geogrid ribs.

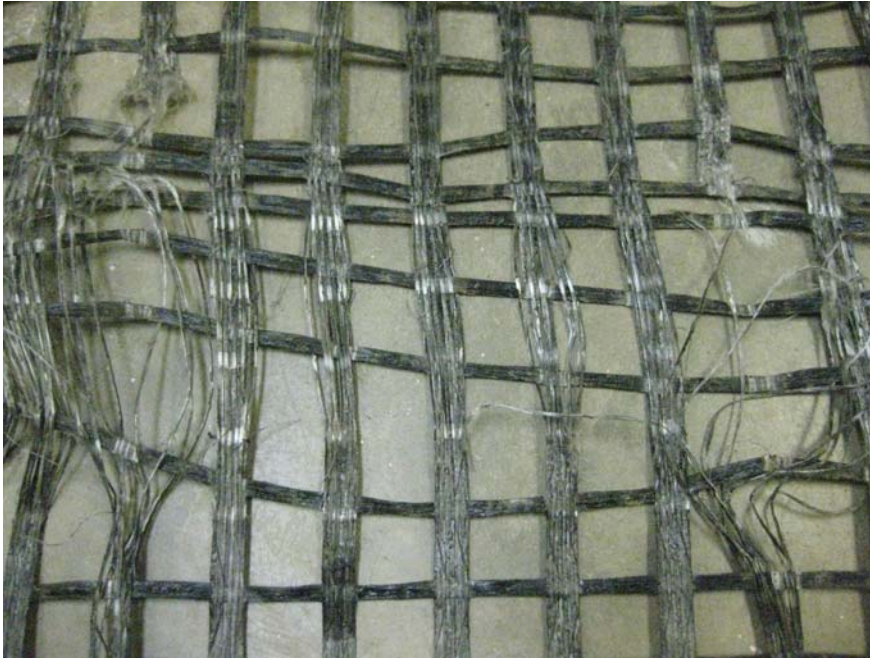
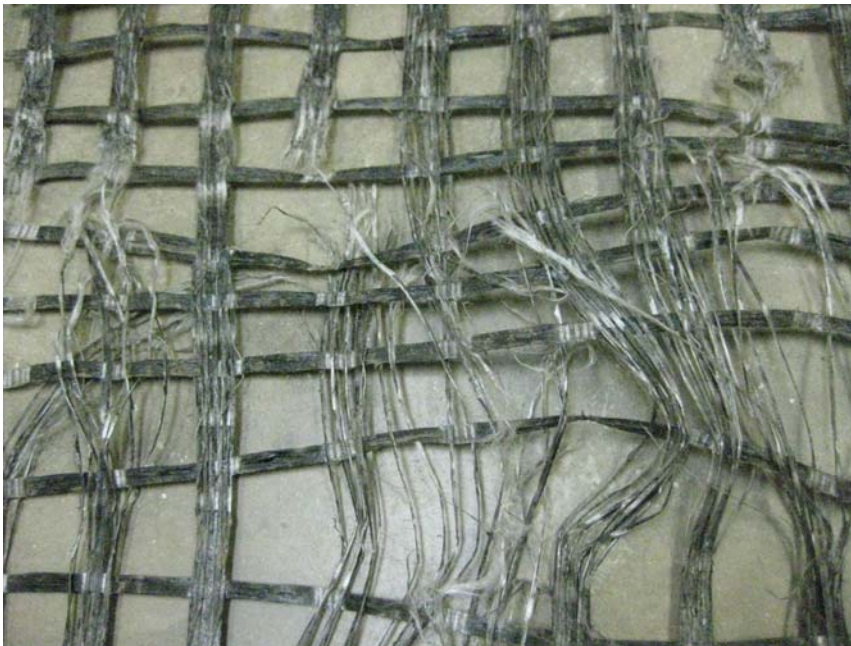
Figure A-4. Junction failure (sliding of a XD rib along MD ribs) and rib rupture of CTMGGU 80 geogrid at the completion of test #3G at 4800 lbs/ft normal load.

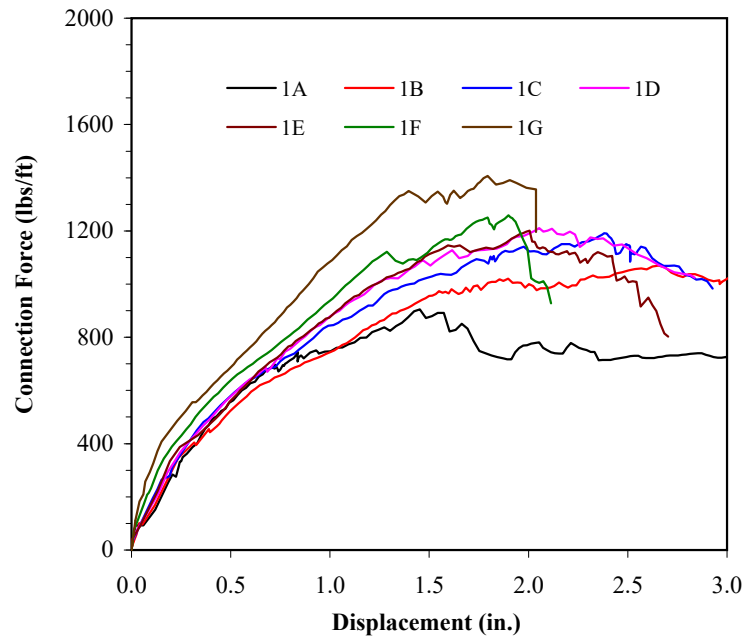
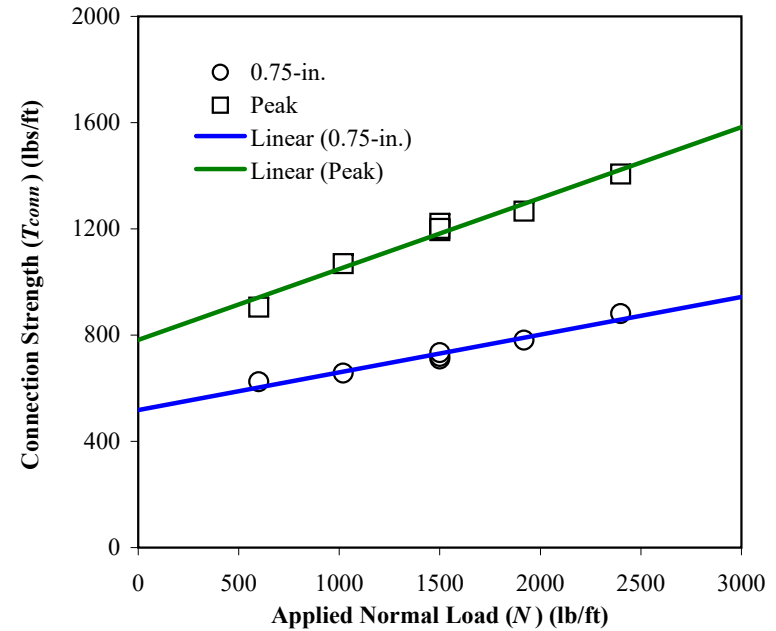
FIGURE NO. C-1  
 PROJECT NO. SGH13020  
 DOCUMENT NO.  
 FILE NO.

TEST SERIES NO. 1: CTMGGU 40 geogrid in machine direction between two courses of 12" deep Omega blocks with compacted AASHTO #57 stone in block cores and spaces between blocks

Test No.	Geogrid Specimen Width <i>W</i> (in.)	Test Normal Stress $\sigma_n$ (psi)	Equivalent Normal Load <i>N</i> (lb/ft)	Approximate No. of Blocks <i>n</i>	Approximate Wall Height <i>h</i> (ft)	0.75-in. Strength $T_{0.75-in}$ (lb/ft)	Peak Strength $T_{peak}$ (lb/ft)	Connection Strength Equations (Strength assumed to be linearly related to <i>N</i> )
1A	32.0	4.2	600	8	5.0	624	905	$T_{0.75-in.} = 515 + (N) \tan ( 8^\circ )$ $T_{peak} = 780 + (N) \tan ( 15^\circ )$
1B	32.0	7.1	1020	13	8.5	656	1069	
1C	32.0	10.4	1500	19	12.5	710	1193	
1D	32.0	10.4	1500	19	12.5	720	1221	
1E	32.0	10.4	1500	19	12.5	734	1201	
1F	32.0	13.3	1920	24	16.0	780	1267	
1G	32.0	16.7	2400	30	20.0	881	1406

Nominal Dimensions of Block: 18" wide x 12" deep xx 8" thick  
 Weight of Full-Size Block: . 86 lbs  
 Average Unit Weight of Facing: 120 pcf.  
 Failure Mode: Rupture of MD geogrid ribs against shear keys in each test.

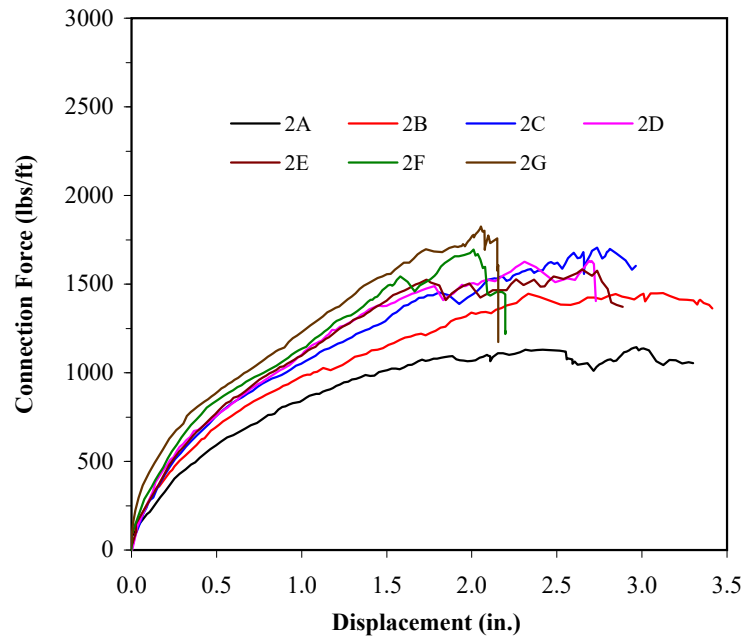
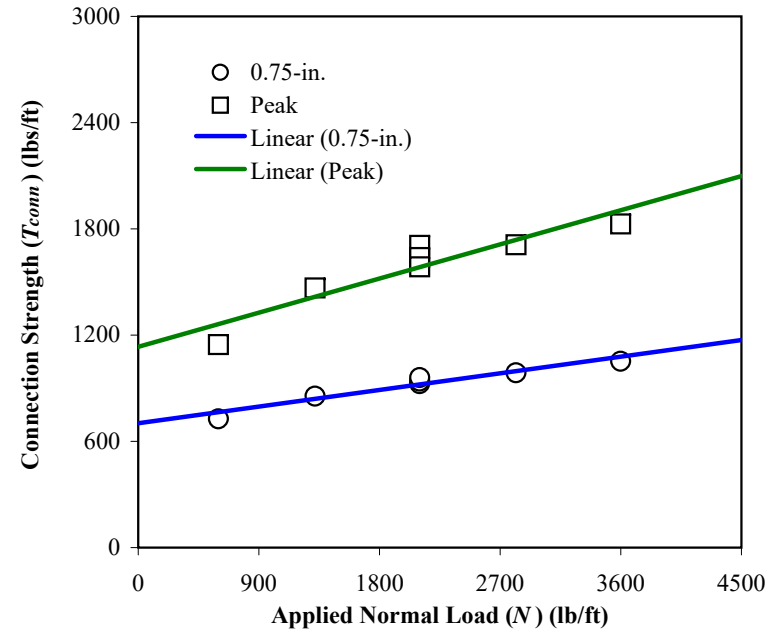
FIGURE NO. C-2  
 PROJECT NO. SGH13020  
 DOCUMENT NO.  
 FILE NO.

TEST SERIES NO. 2: CTMGGU 60 geogrid in machine direction between two courses of 12" deep Omega blocks with compacted AASHTO #57 stone in block cores and spaces between blocks

Test No.	Geogrid Specimen Width <i>W</i> (in.)	Test Normal Stress $\sigma_n$ (psi)	Equivalent Normal Load <i>N</i> (lb/ft)	Approximate No. of Blocks <i>n</i>	Approximate Wall Height <i>h</i> (ft)	0.75-in. Strength $T_{0.75-in}$ (lb/ft)	Peak Strength $T_{peak}$ (lb/ft)	Connection Strength Equations (Strength assumed to be linearly related to <i>N</i> )
2A	32.0	4.2	600	8	5.0	727	1146	$T_{0.75-in.} = 700 + (N) \tan ( 6^\circ )$ $T_{peak} = 1135 + (N) \tan ( 12^\circ )$
2B	32.0	9.2	1320	17	11.0	855	1465	
2C	32.0	14.6	2100	26	17.5	926	1706	
2D	32.0	14.6	2100	26	17.5	939	1637	
2E	32.0	14.6	2100	26	17.5	959	1584	
2F	32.0	19.6	2820	35	23.5	987	1710	
2G	32.0	25.0	3600	45	30.0	1053	1827

Nominal Dimensions of Block: 18" wide x 12" deep xx 8" thick  
 Weight of Full-Size Block: . 86 lbs  
 Average Unit Weight of Facing: 120 pcf.  
 Failure Mode: Rupture of MD geogrid ribs against shear keys in each test.

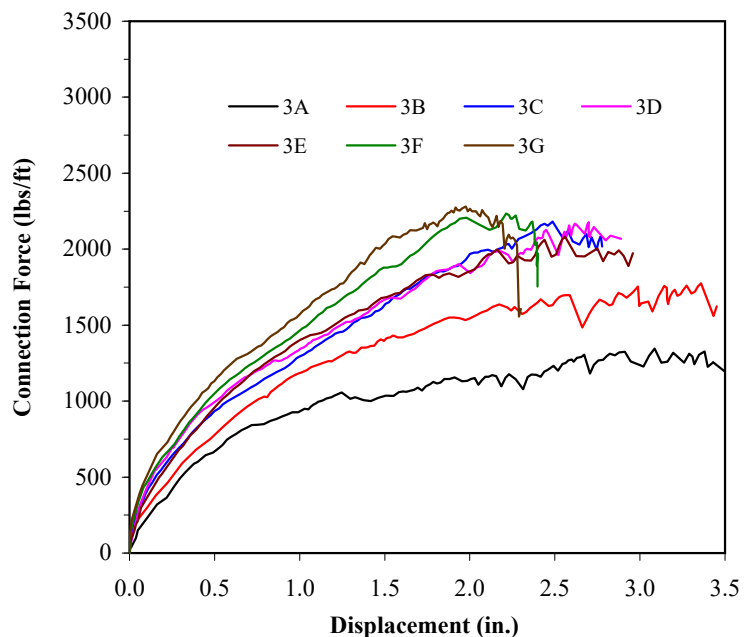
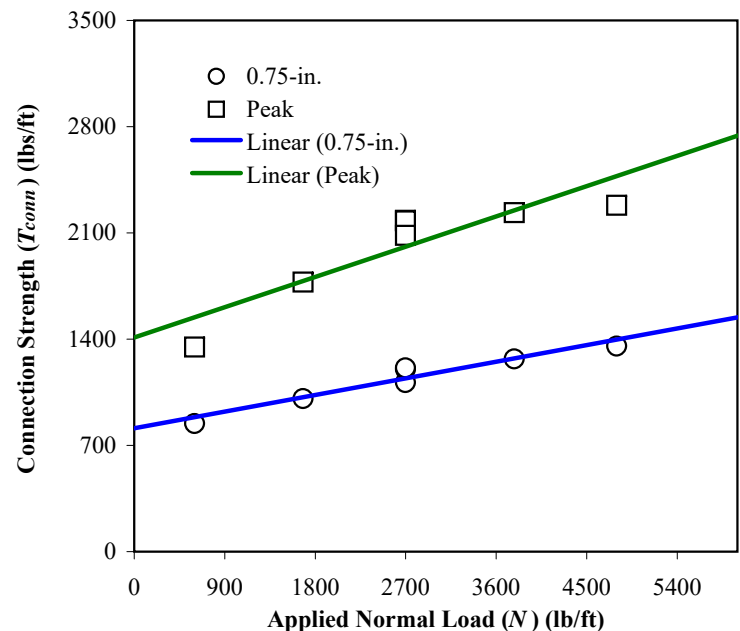
FIGURE NO. C-3  
 PROJECT NO. SGI13020  
 DOCUMENT NO.  
 FILE NO.

TEST SERIES NO. 3: CTMGGU 80 geogrid in machine direction between two courses of 12" deep Omega blocks with compacted AASHTO #57 stone in block cores and spaces between blocks

Test No.	Geogrid Specimen Width <i>W</i> (in.)	Test Normal Stress $\sigma_n$ (psi)	Equivalent Normal Load <i>N</i> (lb/ft)	Approximate No. of Blocks <i>n</i>	Approximate Wall Height <i>h</i> (ft)	0.75-in. Strength $T_{0.75-in}$ (lb/ft)	Peak Strength $T_{peak}$ (lb/ft)	Connection Strength Equations (Strength assumed to be linearly related to <i>N</i> )
3A	32.0	4.2	600	8	5.0	844	1347	$T_{0.75-in.} = 815 + (N) \tan ( 7^\circ )$ $T_{peak} = 1410 + (N) \tan ( 12^\circ )$
3B	32.0	11.7	1680	21	14.0	1008	1775	
3C	32.0	18.8	2700	34	22.5	1114	2181	
3D	32.0	18.8	2700	34	22.5	1200	2178	
3E	32.0	18.8	2700	34	22.5	1210	2083	
3F	32.0	26.3	3780	47	31.5	1268	2234	
3G	32.0	33.3	4800	60	40.0	1354	2281

Nominal Dimensions of Block: 18" wide x 12" deep xx 8" thick  
 Weight of Full-Size Block: . 86 lbs  
 Average Unit Weight of Facing: 120 pcf.  
 Failure Mode: Rupture of MD geogrid ribs against shear keys in each test.
