## BTRA TEST LABORATORIES TEST REPORT

SAMPLE NO.	1700900/TTG/1
SAMPLE MARK	GEO GRID CTM/BT-160/40/20

# **Creep-Rupture Behavior of 1100/192DTEX, 1000 Denier High Tenacity PET Yarn**

**Installation Damage Testing  
of Coated PET Geogrid:  
40 kN/m  
In Silty Sand**

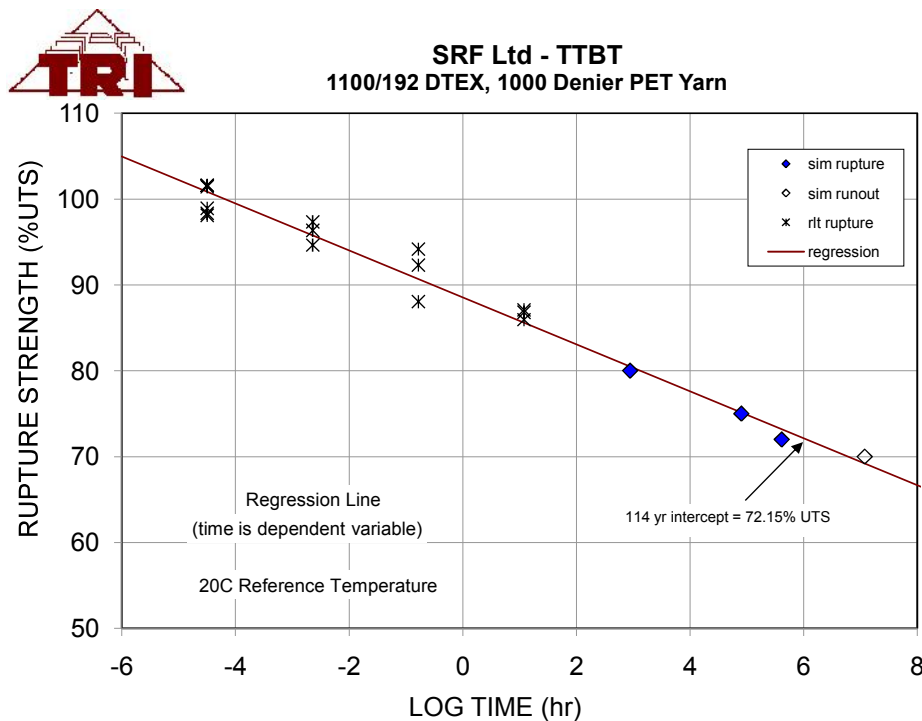
*Creep-Rupture* - Three of four SIM tests were taken to rupture. The creep rupture data along with the RLT data was plotted and evaluated as shown in the following figure.

The 75- and 114-year creep rupture-based reduction factors presented in Table 1 have been estimated from the limited creep testing reported herein. These reduction factors are reasonably consistent with previously reported rupture-based reduction factors for yarns used in polyester (PET) geosynthetics. A more extensive testing program would be necessary to confirm the accuracy of these results.

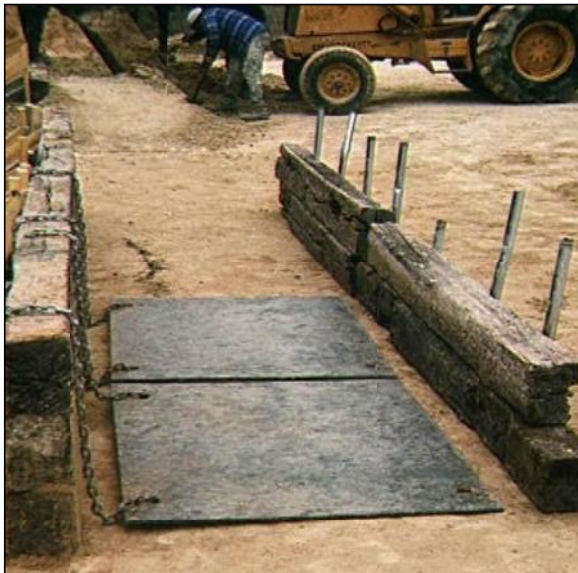
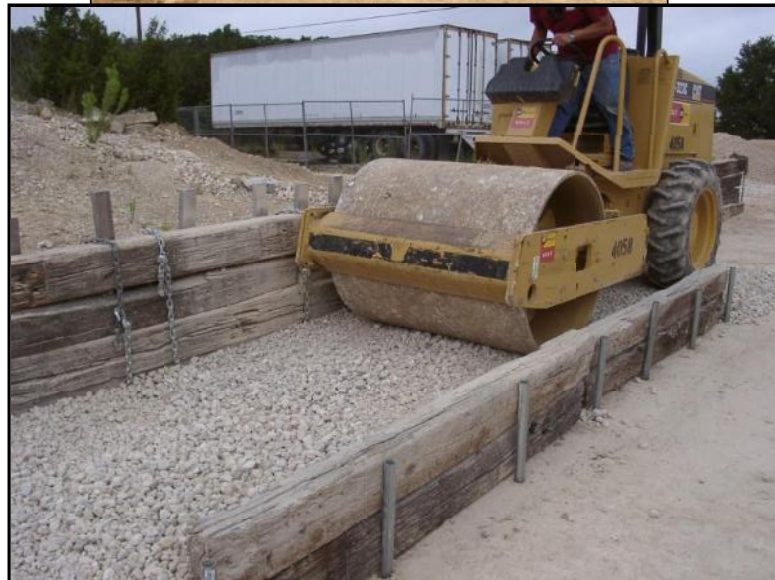
LIFTING PLATES POSITIONED BETWEEN TIES AND COVERED  
WITH FIRST LIFT OF COMPACTED SOIL/AGGREGATE

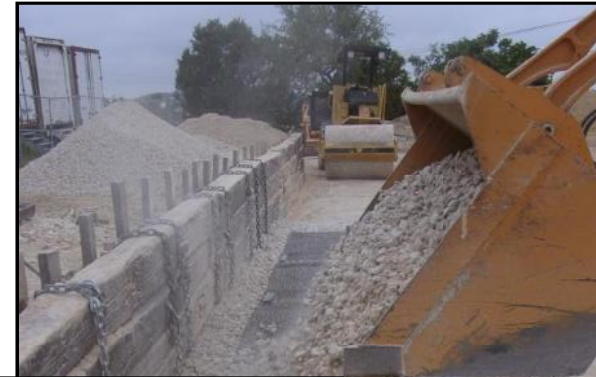
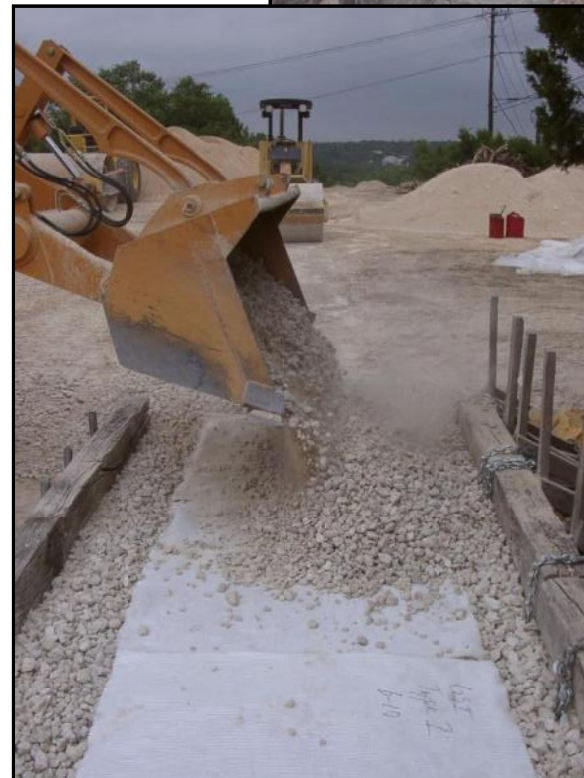
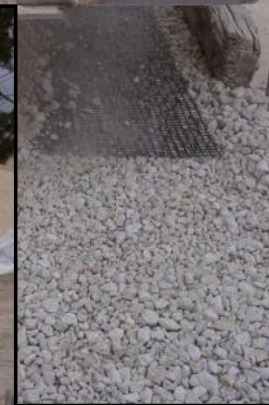
GEOSYNTHETIC POSITIONED OVER COMPACTED BASE AND  
COVERED

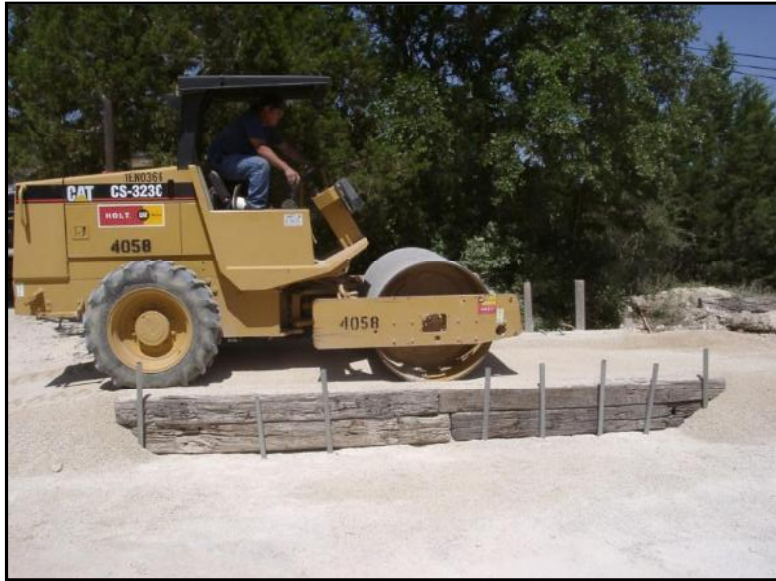
COVER SOIL/AGGREGATE IS UNIFORMLY SPREAD AND COMPACTED USING FIELD-SCALE EQUIPMENT AND PROCEDURES

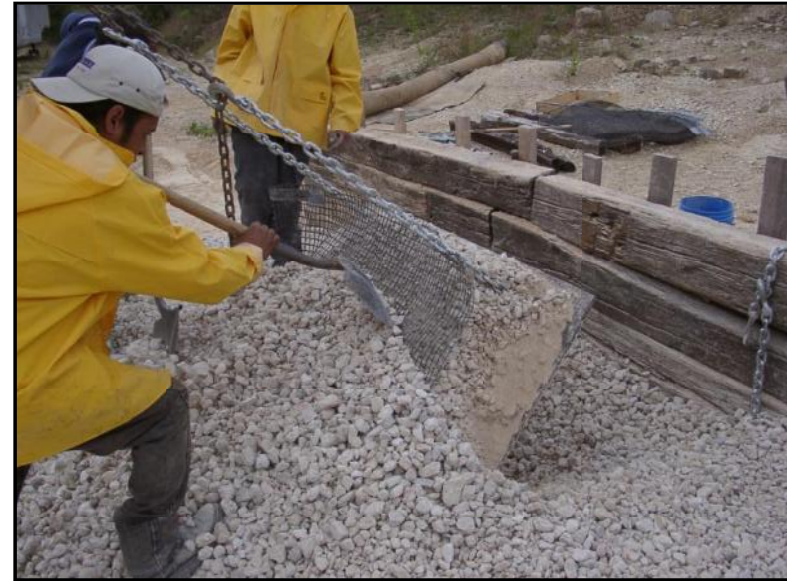
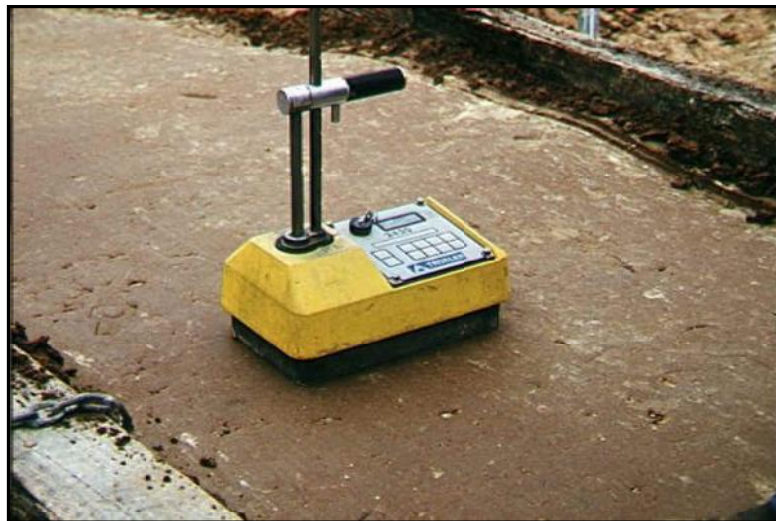
THE DENSITY OF COMPACTED SOIL IS MEASURED

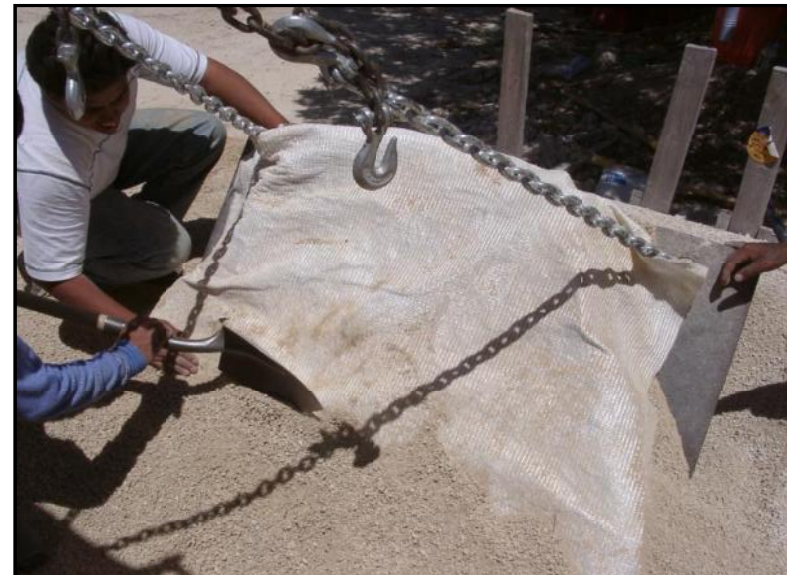
THE STEEL PLATES ARE TILTED TO FACILITATE EXHUMATION

To exhume the geosynthetic, railroad ties were removed and one end of each plate was raised with lifting chains. After raising the plate to about 45°, soil located near the bottom of the leaning plate was removed and, if necessary, the plate was struck with a sledgehammer to loosen the fill. The covering soil/aggregate was then carefully removed from the surface while "rolling" the geosynthetic away from the underlying soil/aggregate. This procedure assured a minimum of exhumation stress.

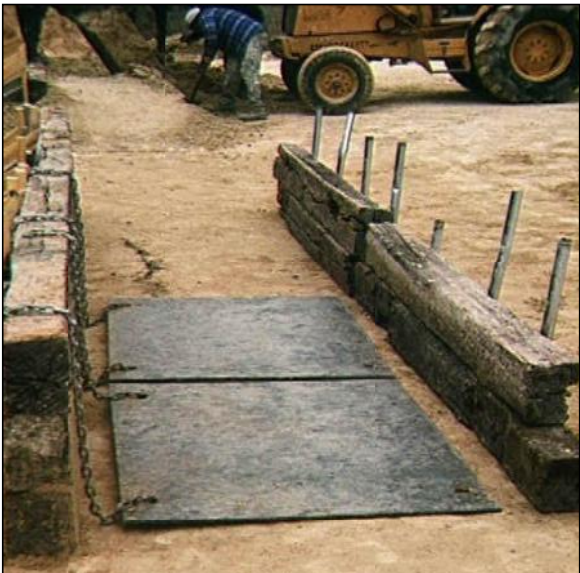
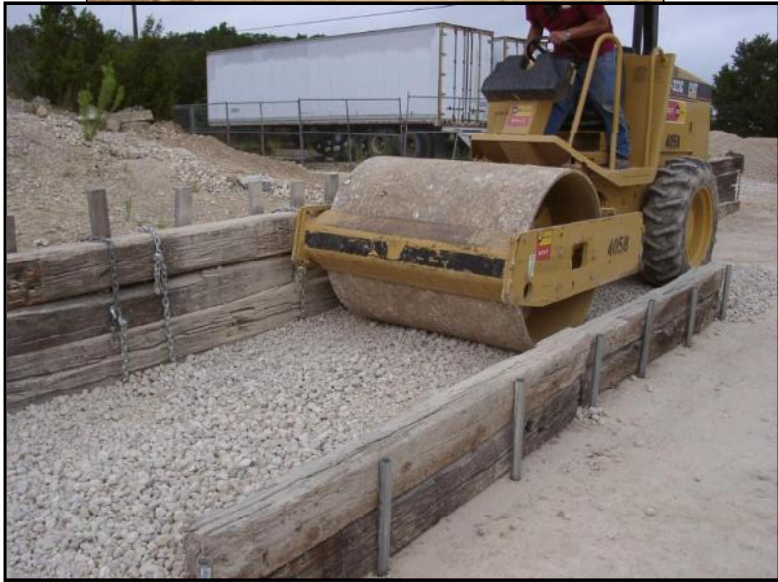
LIFTING PLATES POSITIONED BETWEEN TIES AND COVERED WITH FIRST LIFT OF COMPACTED SOIL/AGGREGATE

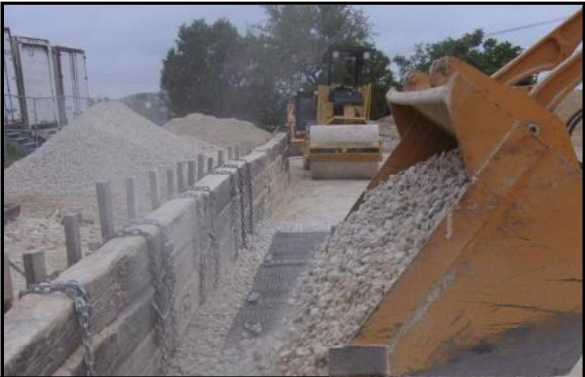
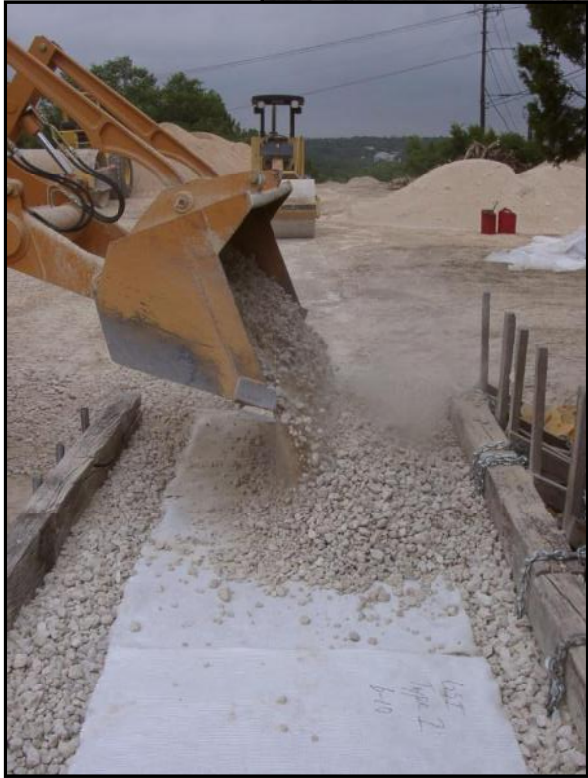
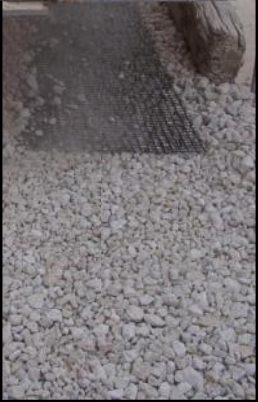
GEOSYNTHETIC POSITIONED OVER COMPACTED BASE AND COVERED

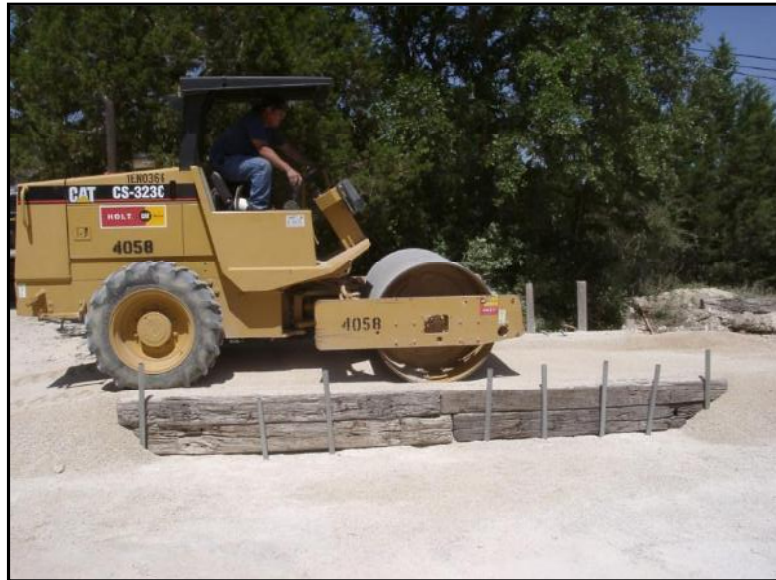
COVER SOIL/AGGREGATE IS UNIFORMLY SPREAD AND COMPACTED USING FIELD-SCALE EQUIPMENT AND PROCEDURES

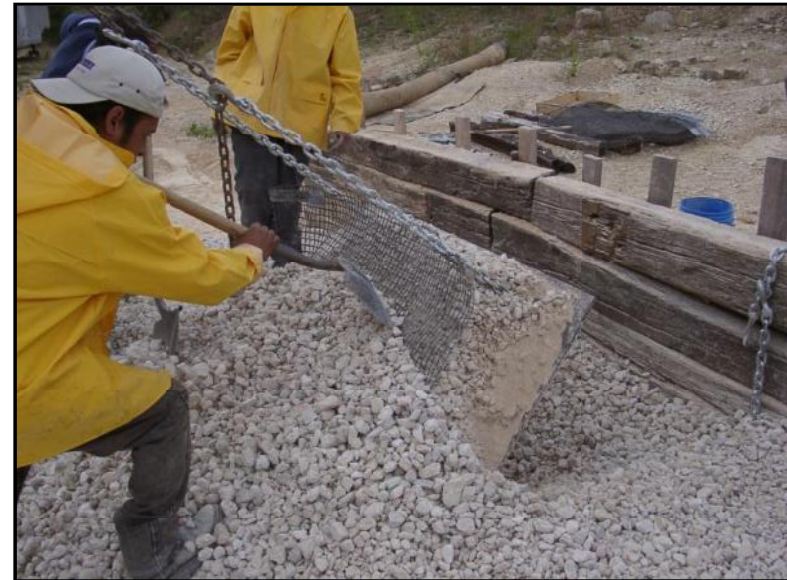
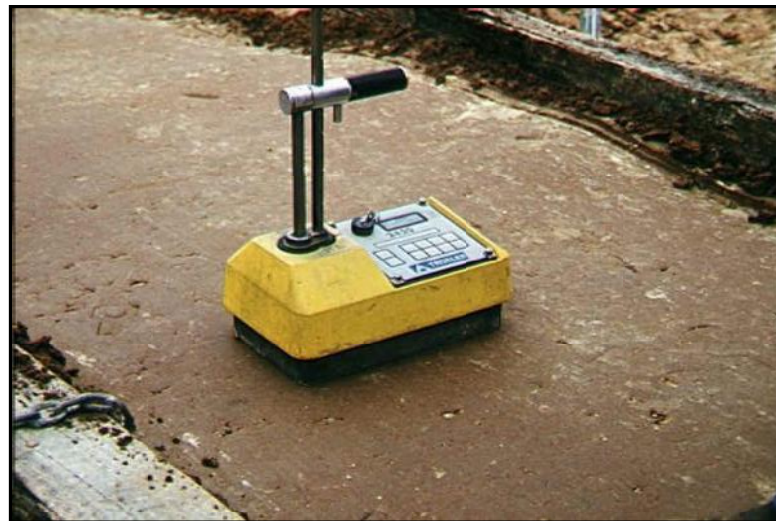
THE DENSITY OF COMPACTED SOIL IS MEASURED

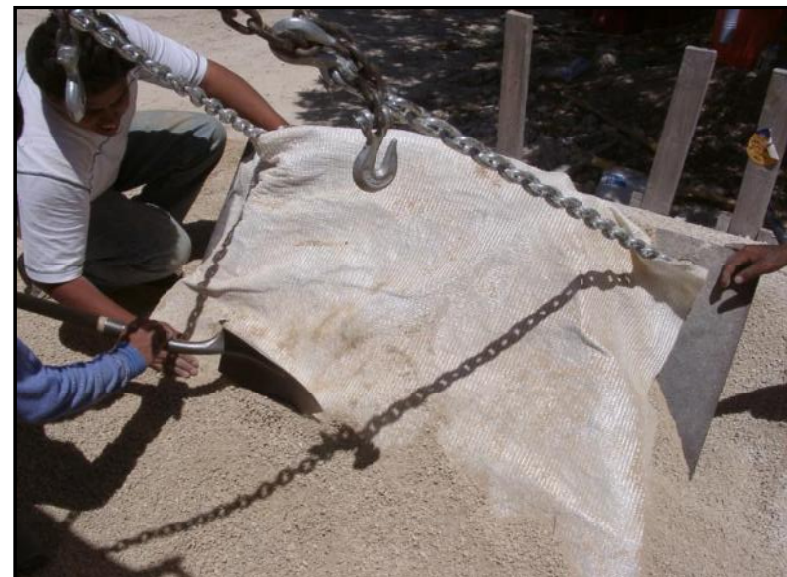
THE STEEL PLATES ARE TILTED TO FACILITATE EXHUMATION

To exhume the geosynthetic, railroad ties were removed and one end of each plate was raised with lifting chains. After raising the plate to about 45°, soil located near the bottom of the leaning plate was removed and, if necessary, the plate was struck with a sledgehammer to loosen the fill. The covering soil/aggregate was then carefully removed from the surface while "rolling" the geosynthetic away from the underlying soil/aggregate. This procedure assured a minimum of exhumation stress.

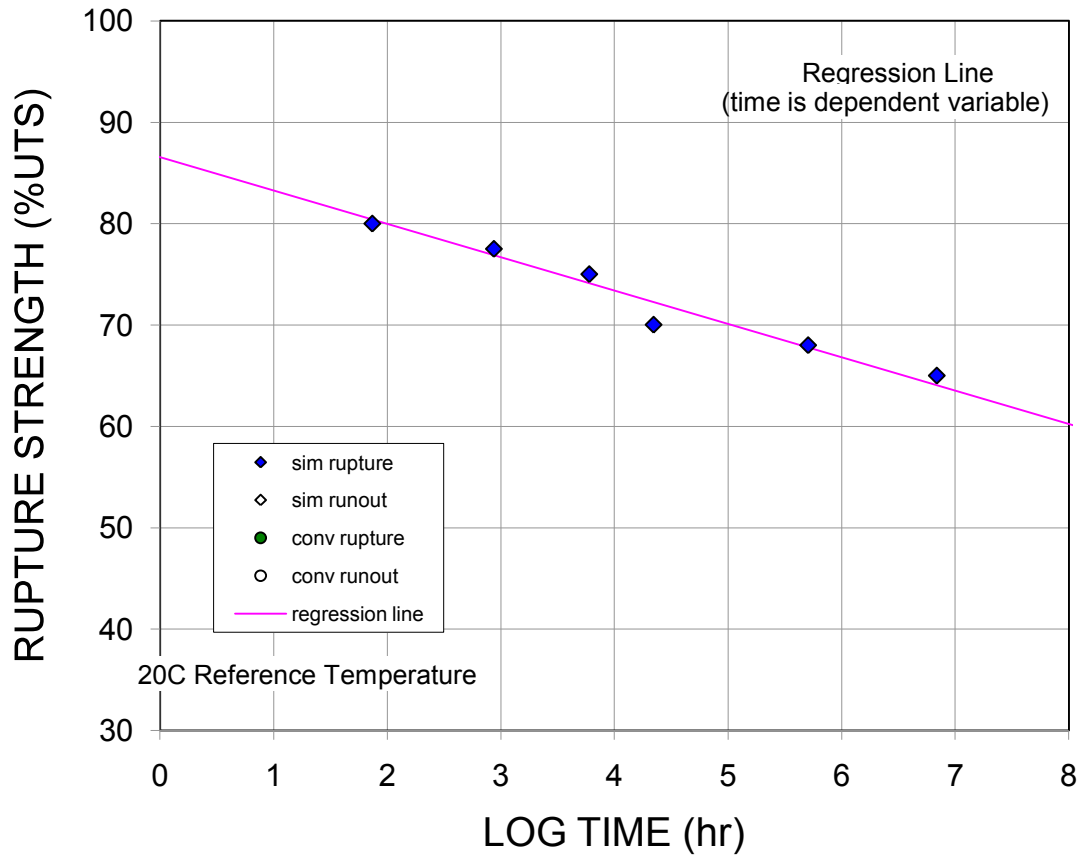
**Figure 1. Creep Rupture Curve – 80 kN/m Geogrid (Machine Direction)**

*Creep Rupture.* Table 4 present test data and rupture curve calculations and Figure 1 presents the associated creep rupture curve for the material tested. A creep rupture curve for each SIM test is presented in the appendix.

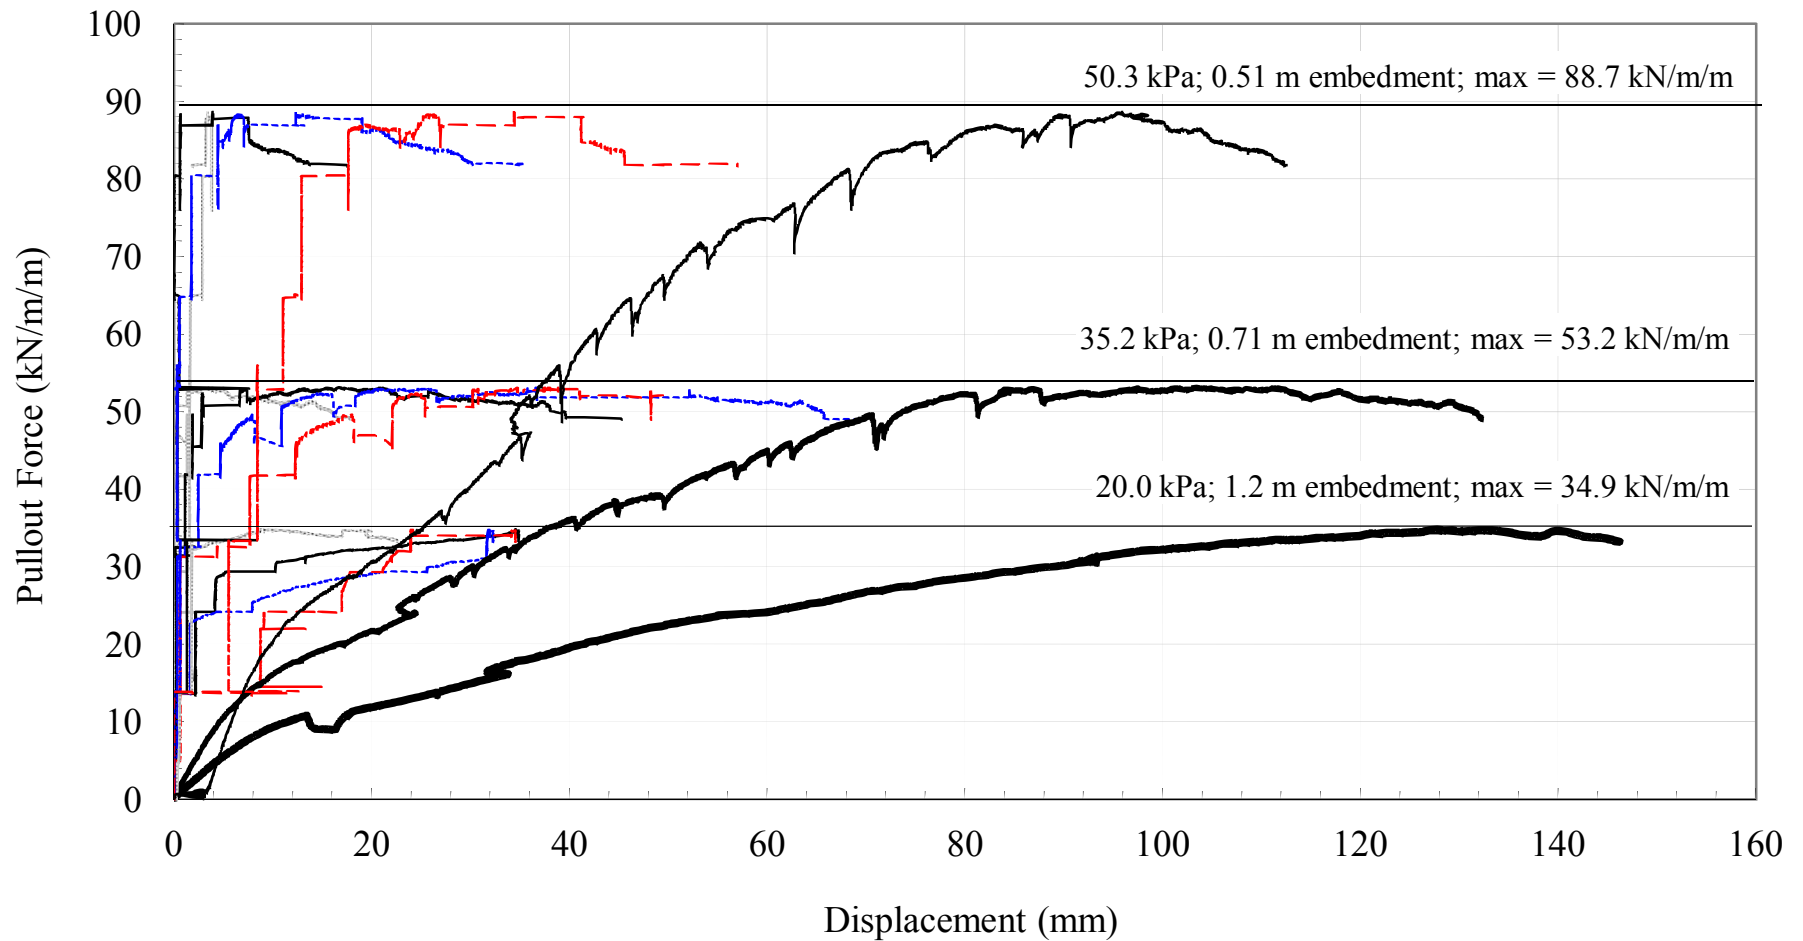
80 kN/m Geogrid in Sandy Gravel - Pullout @ 20.0, 35.2 & 50.3 kPa

Note 1:  $C_i = P / (C * L_e * (c' + \sigma'_v \tan \phi'))$  where P = pullout resistance per unit width; C = effective unit perimeter (2 for geosynthetics);  $L_e$  = embedment length, and  $\sigma'_v$  = effective vertical stress.

Note 2: The Mohr-Coulomb strength parameters,  $c'$  and  $\phi'$ , used in this calculation were determined at normal stresses ranged from 20 kPa to 35 kPa.
